CASE HISTORY - Weatherford-ENI - Italy 925 Ball Valve

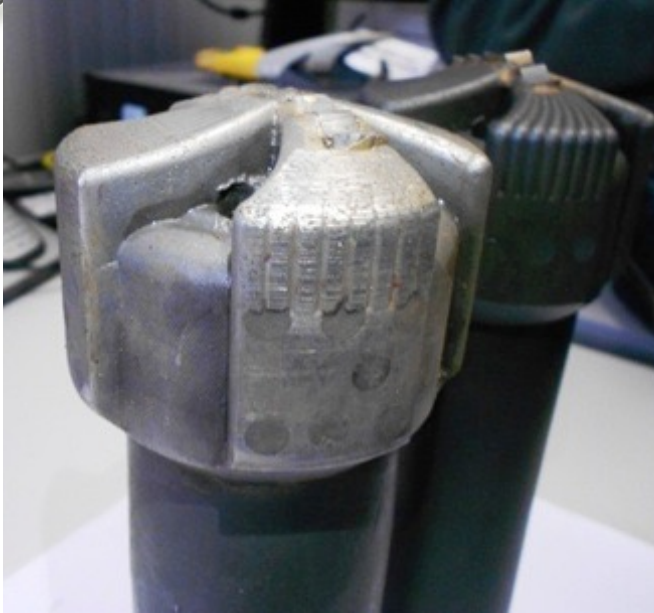
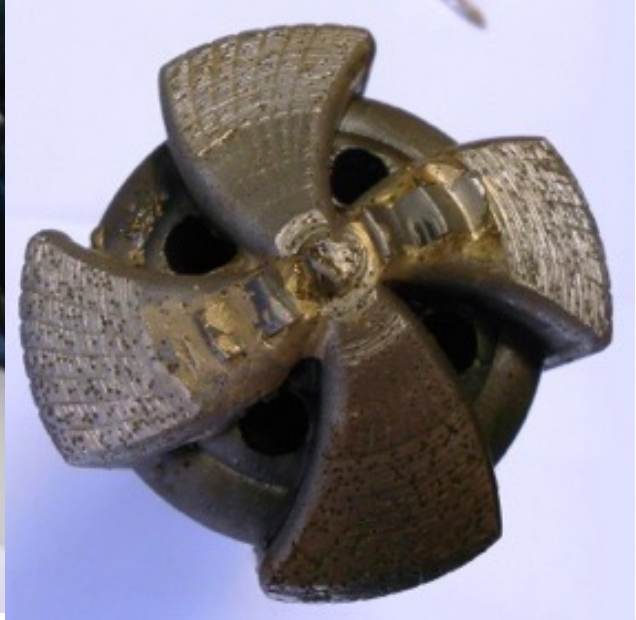
First Run cut top part of ball valve in 5 hrs
Motor Failed

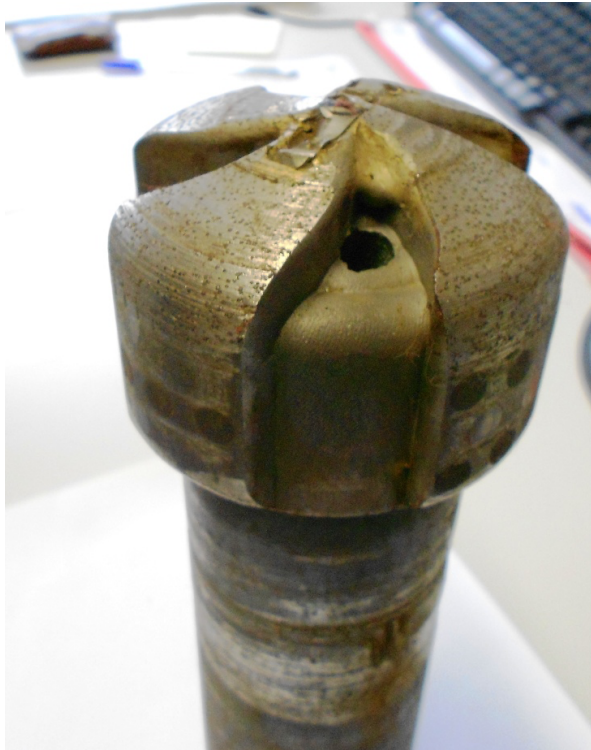
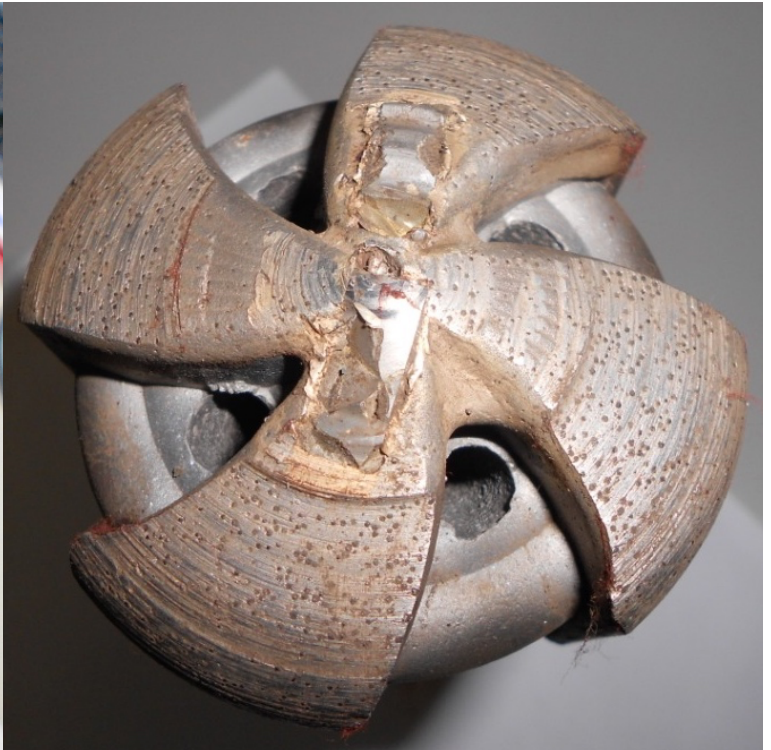
Second Run cut bottom part of Ball Valve in 4 hours
