## Case History Incoloy 925 Flapper

### Job Execution Well X-0X

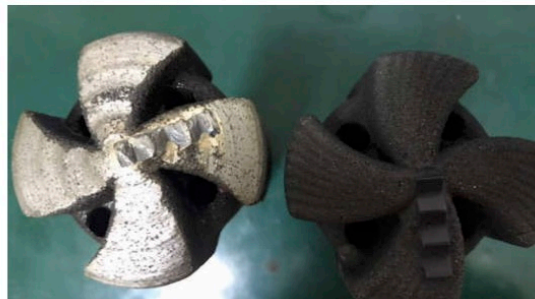
- Successfully milled out the flapper and regain access to the string.

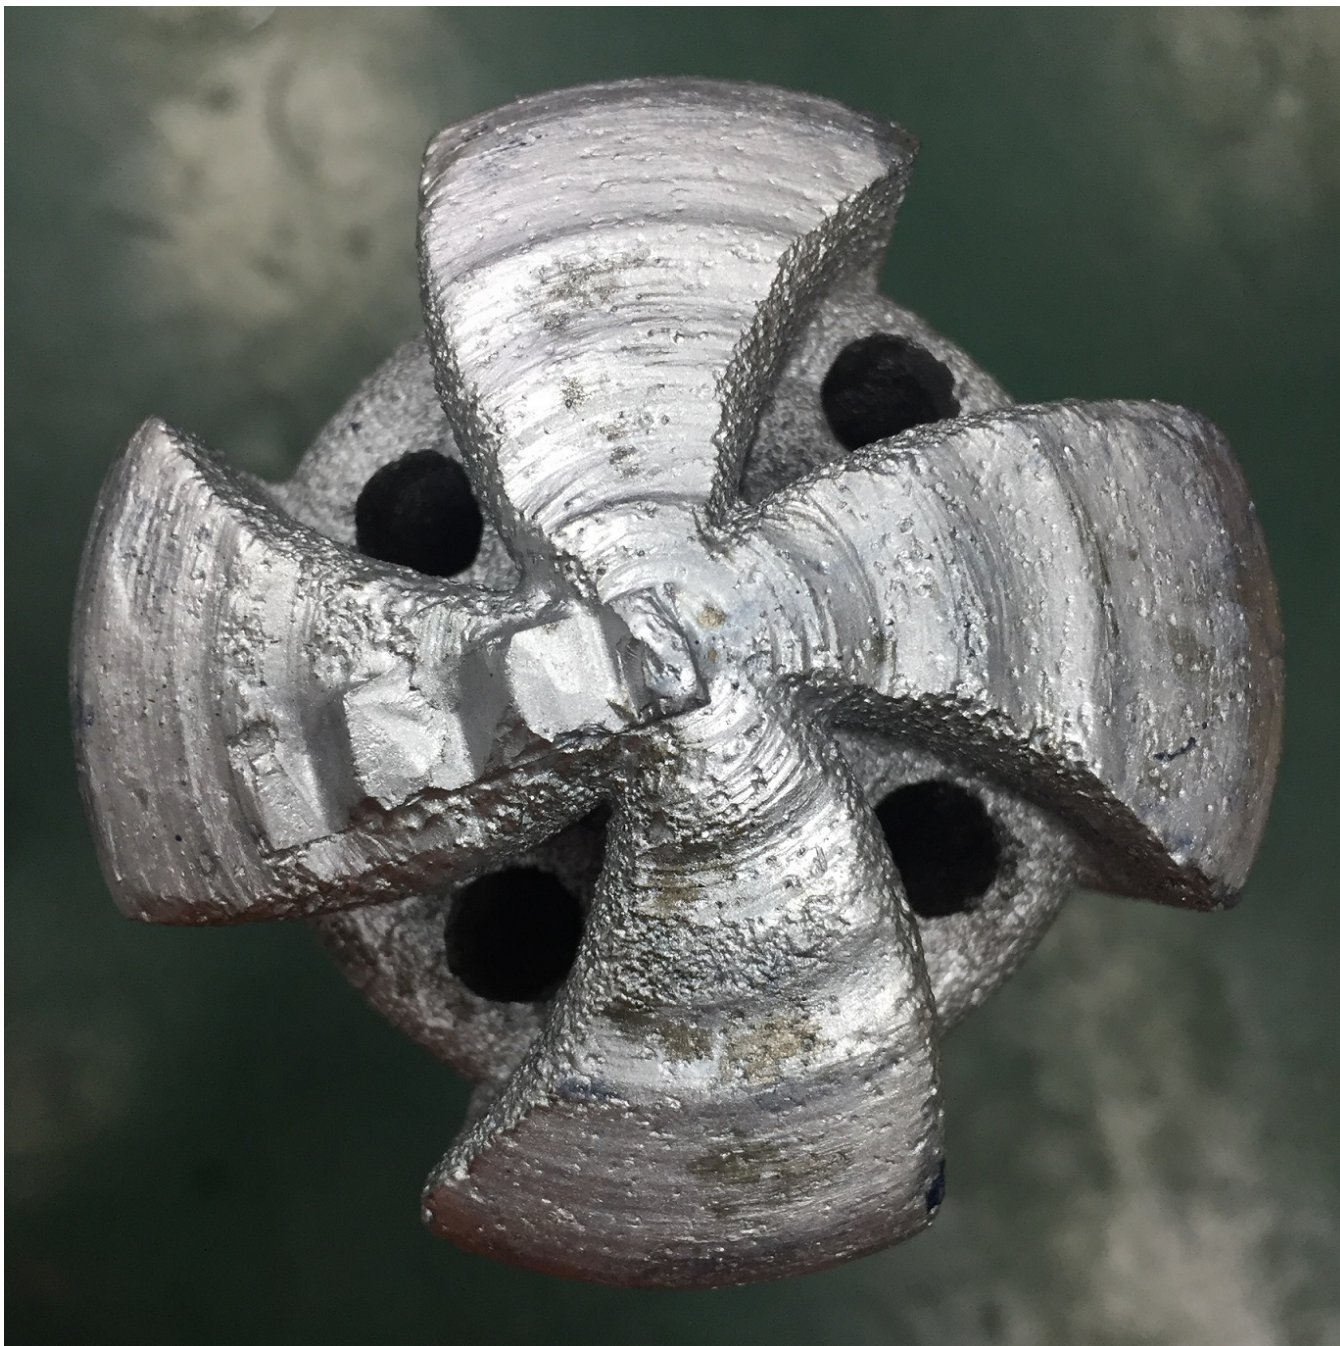
Our 2.350" MX, Diamond-Impreg Mill was run for 10 hours milling to cut up the loose flapper. The mill produced no cuttings larger than particle size.  
Mill wear set. 15%
