Case History  
GOM Below 24,000'  
5 3/4" x 4 1/2" XDS  
HES "HHH" Production Packer

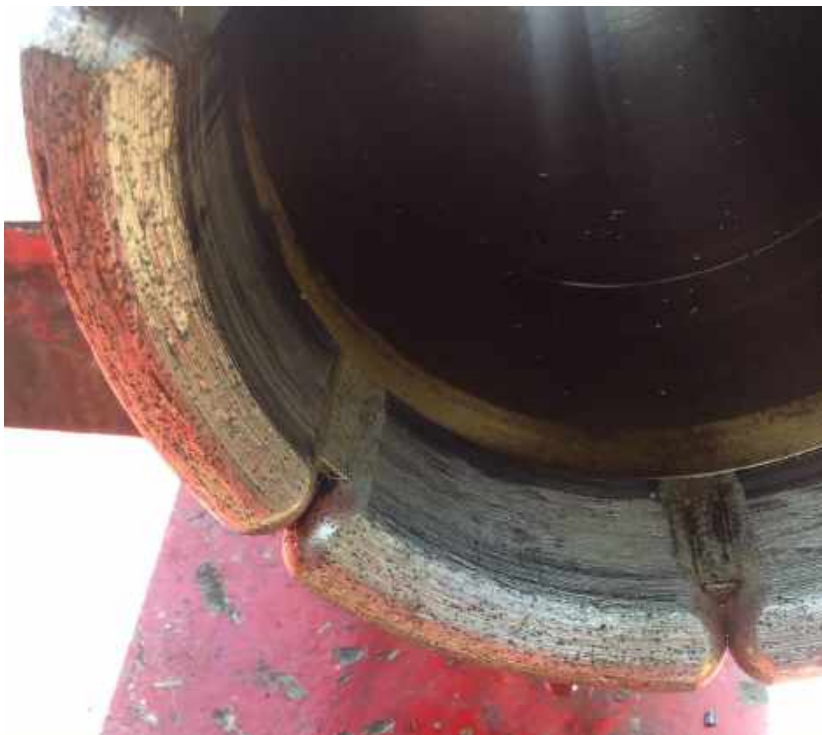
From Client: First Shoe

"At this time we have 12 – 12-1/2" Milled. The portion of the Packer that we are on now is 5.750" O.D. and has a Wall thickness of 1.05". Very tough and slow going due to being limited on RPMs by the torques required to rotate at nearly 24,000-feet. Still cutting tho"

"Some Good News this morning. We have been on bottom a total of 42-hrs w/ Rotating Hours at 40-hrs. Total hole milled has been ~26.0" as of 06:30-hrs this morning. The Shoe began showing signs of pressure increase (+120-psi) on bottom. We are POOH now pumping out to keep the milled particles above the shoe until we clear the 7.00" Liner Top. GOOD RUN!!!!!!!!!"

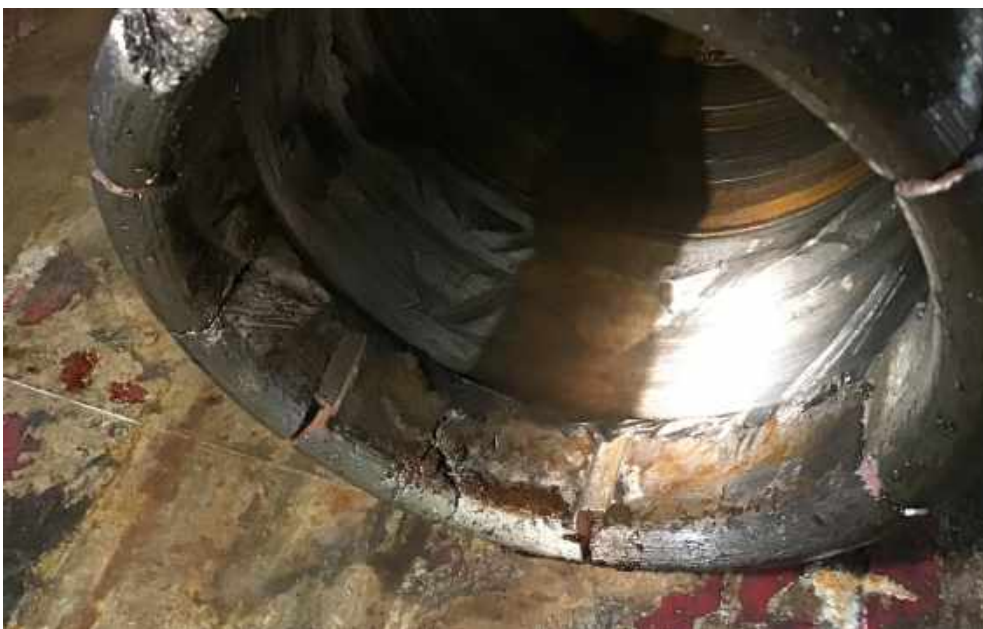
2nd Shoe Total 12 + 68 = 80 Hours Rotating

"Ran the last Shoe for 12-hrs. Looked like it was brand new. A ring directly above the skip section was spinning the entire time.

"Here is Shoe #2 after 68-hours of Rotating. By measurements and Torque Indications on bottom, I feel that we are in the Packer Slips. Had to jar the Shoe free twice in this run with 50K Loads x 15 Impacts and again with 50K Loads x 2 Impacts. Max overpull was 60K to free. You can see sever wear inside along with one broken blade. Also had parts of the packer wedged internal at the top of the Blades. Just like a "good watch" took a beating and kept on ticking. Running a carbide shoe for the last little distance due to timing of boat reaching platform with the third Diamond Shoe. Will let you know the outcome."

Resort to a third run of packer mill to allow getting rougher to stop the spinning.
