Ball Seat Milling Yard Test Report

Subject: Evaluate performance of two different mill designs to mill out ball seat subs on Ravn A-1 to liner drift ID of 3.7".

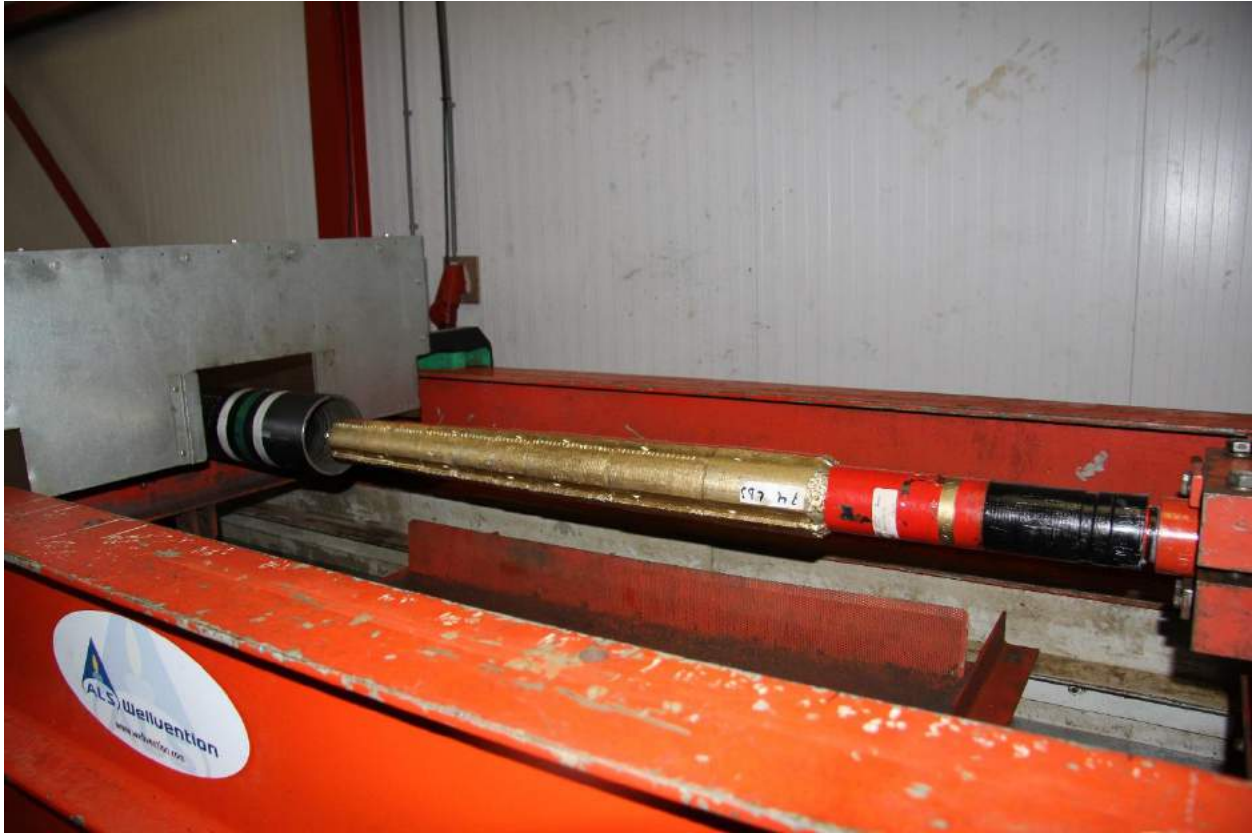
Picture below show the test setup of the ALS Wellvention test bay.

All mill tests have been performed with a 2-7/8" spirostar motor and a flowrate of 350 lpm.

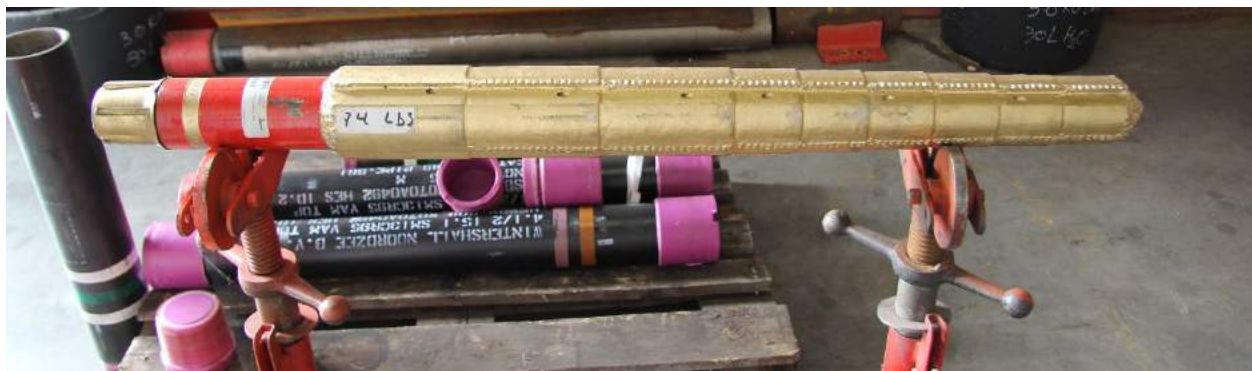
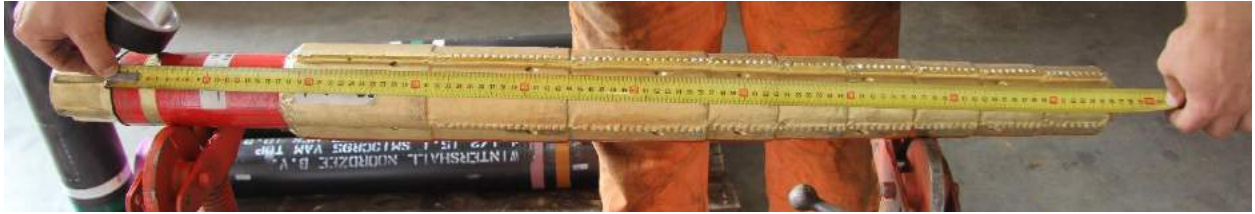
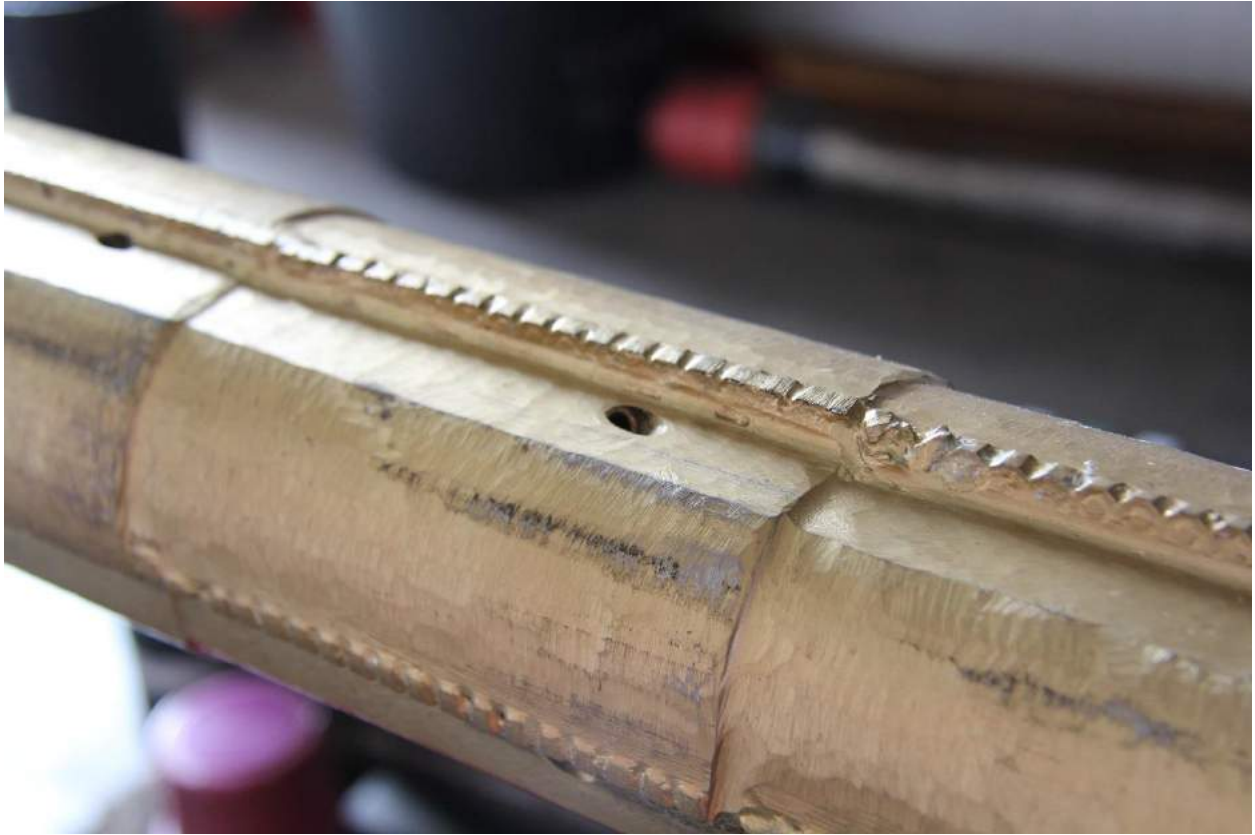
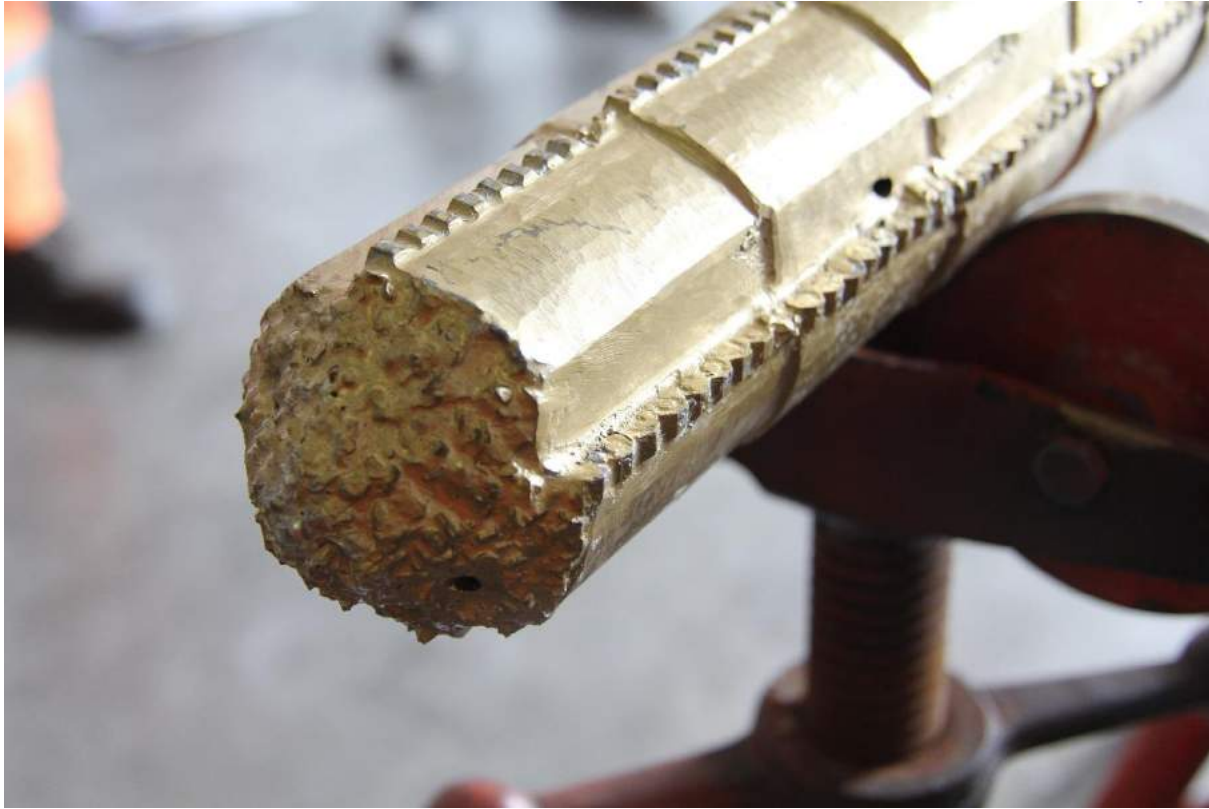
The Weatherford step mill is divided in nine stages. Each stage is 1/8" larger / smaller than the previous stage. The first stage is 2.7" the last stage 3.7" in OD. Length of the entire mill is 1m. The mill is equipped with octagonal shaped tungsten carbide cutter elements. It provides 24 circulation ports at the sides and 2 circulation ports at the top. It has backreaming features on the shoulder.

DIM	INCHES	MM
"A"	2.700	68.58
"B"	2.825	71.76
"C"	2.950	74.93
"D"	3.075	78.11
"E"	3.200	81.28
"F"	3.325	84.46
"G"	3.450	87.63
"H"	3.575	90.81
"J"	3.700	93.98

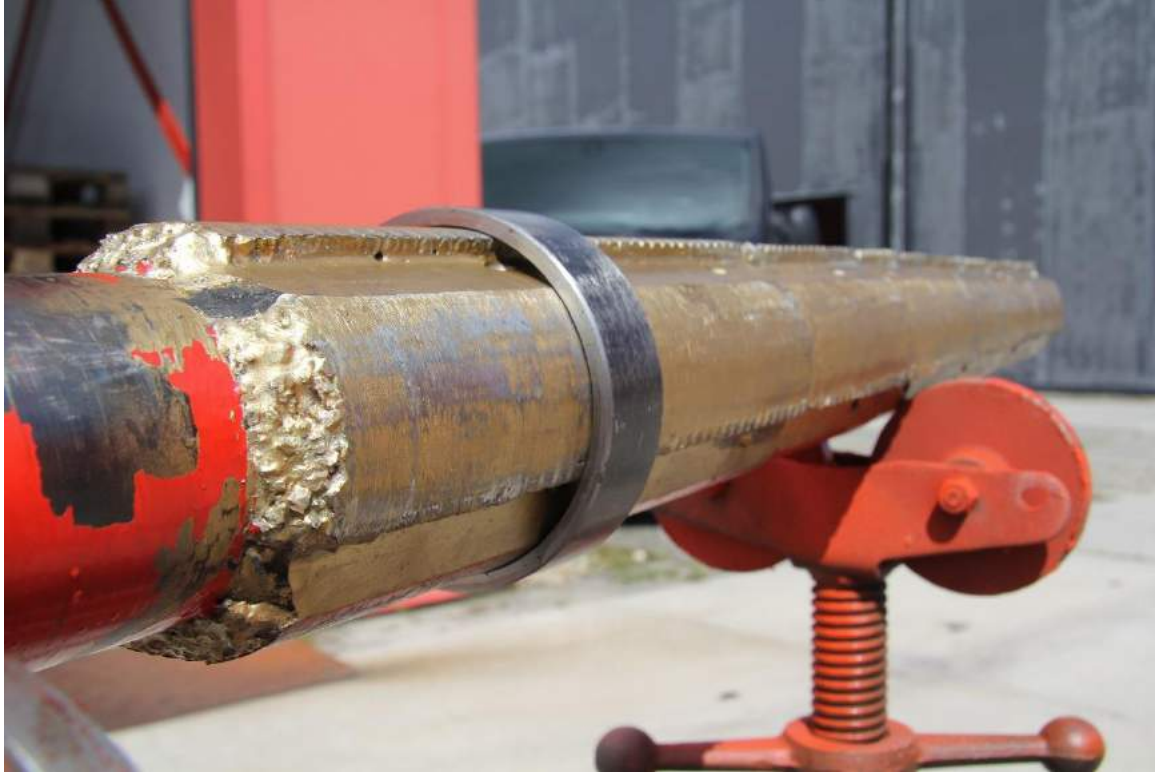
#1 – Drifted milled out ball seat with 3.7" – drift fits through ball seat sub.

#2 – Checked OD of the mill with 3.7" gauge ring – not undergauged

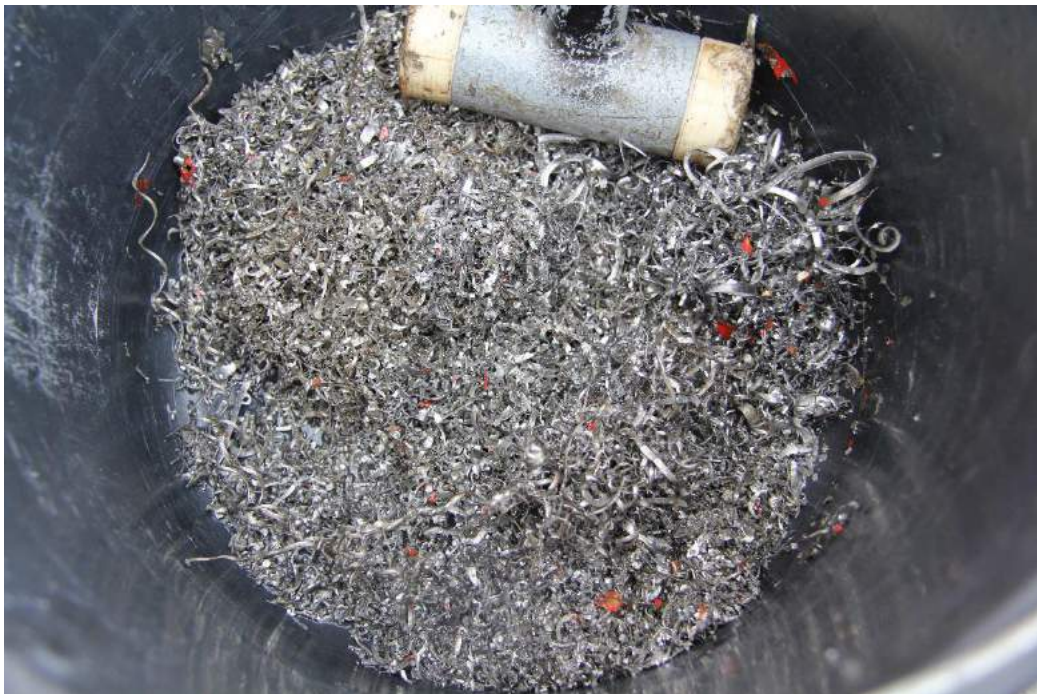
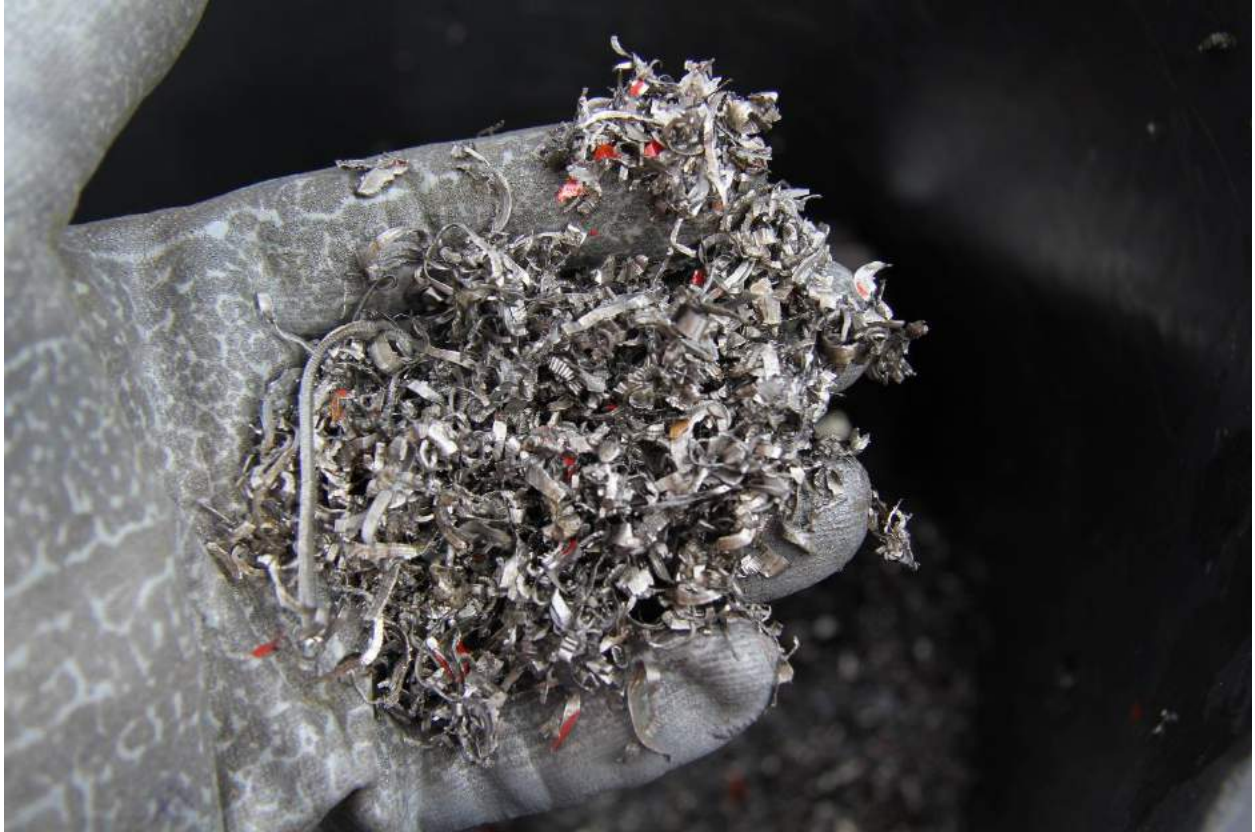
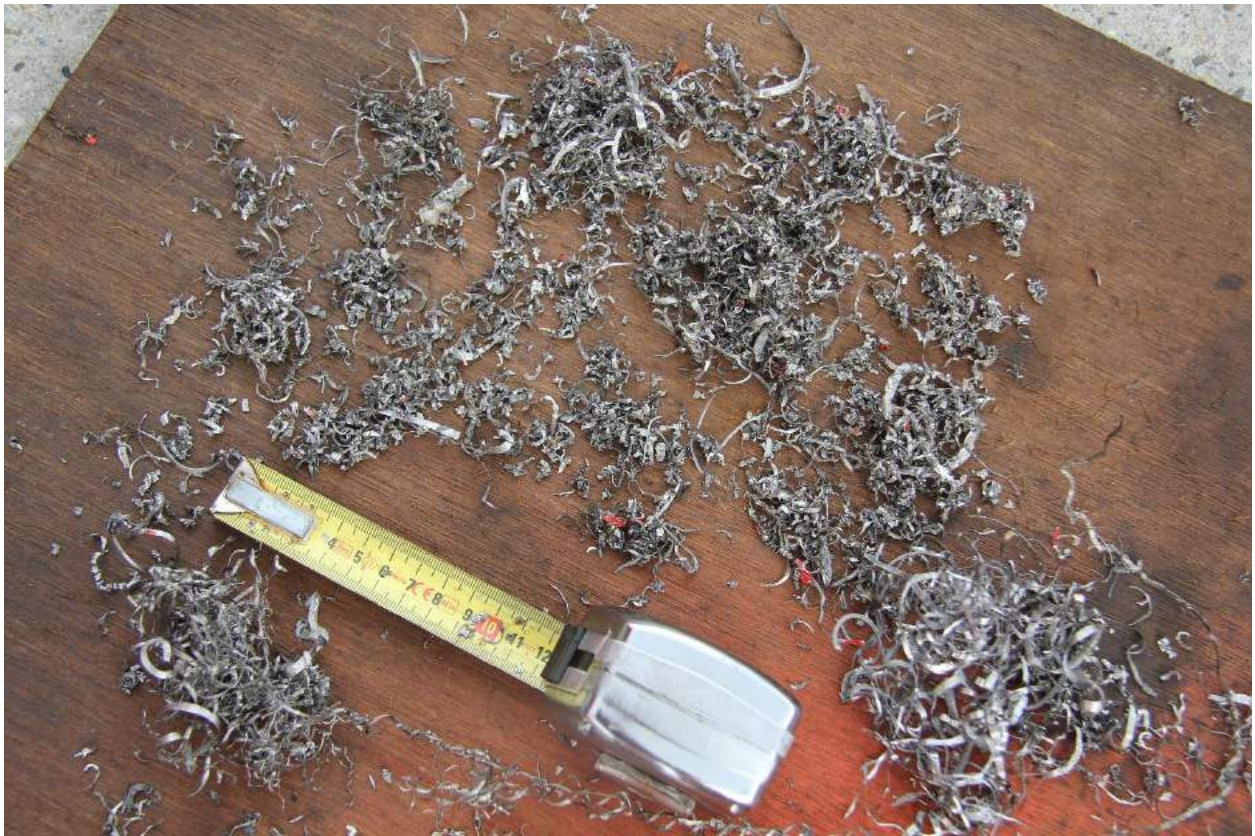
#3 – For amount and shape of swarf created refer to pictures below.

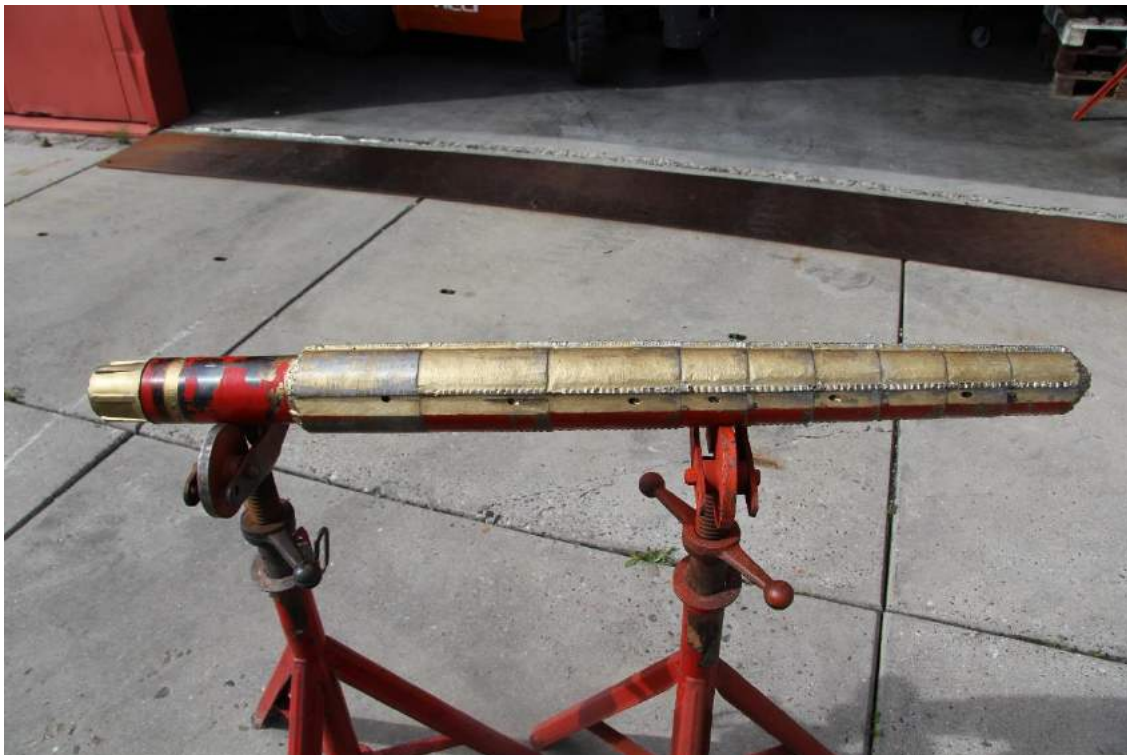
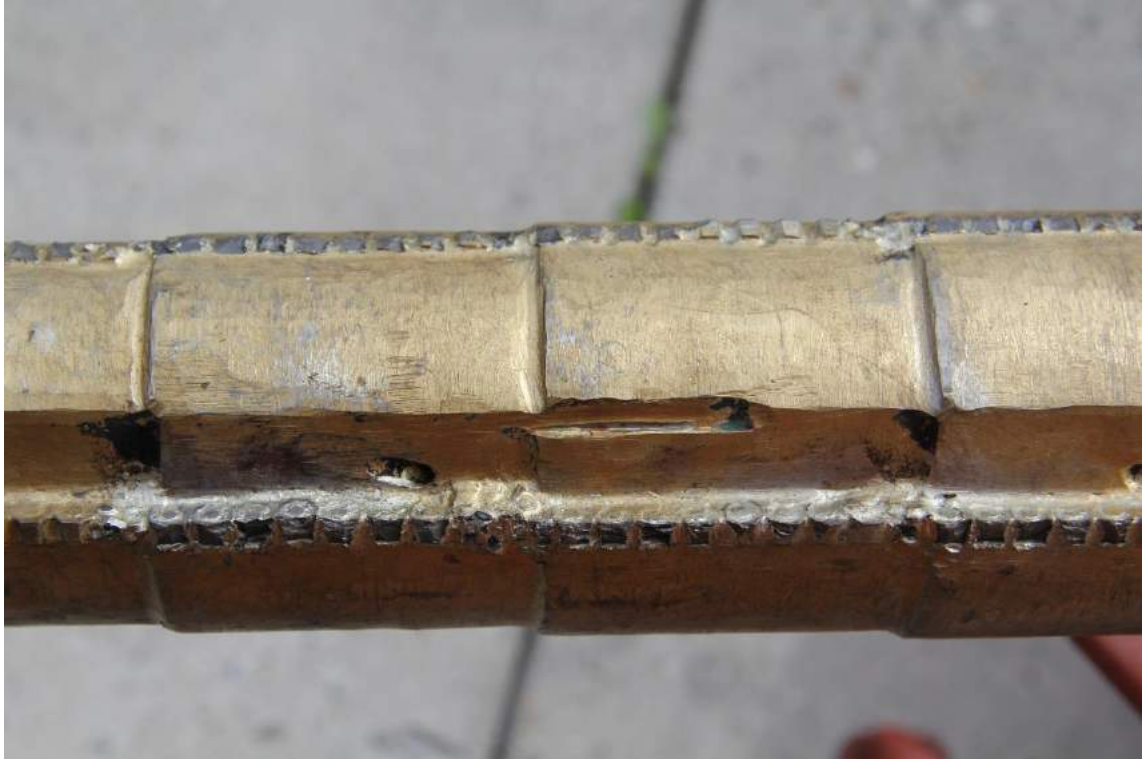
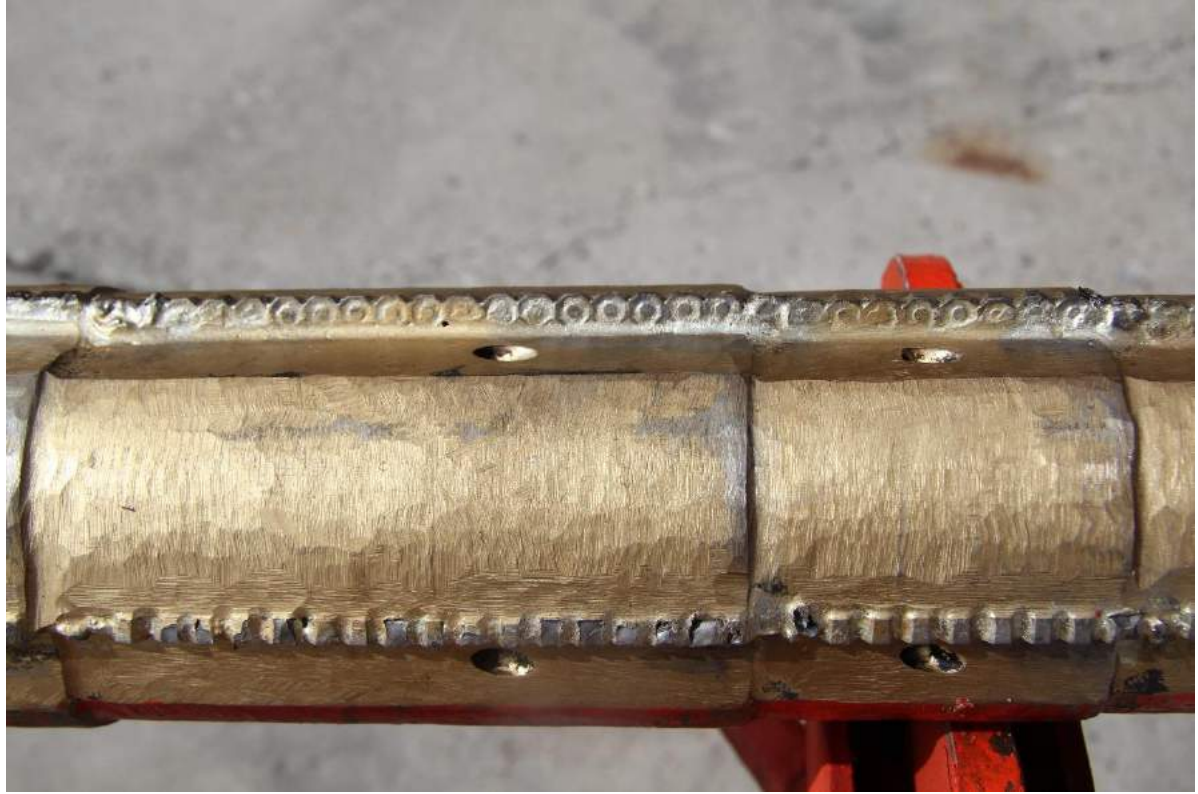
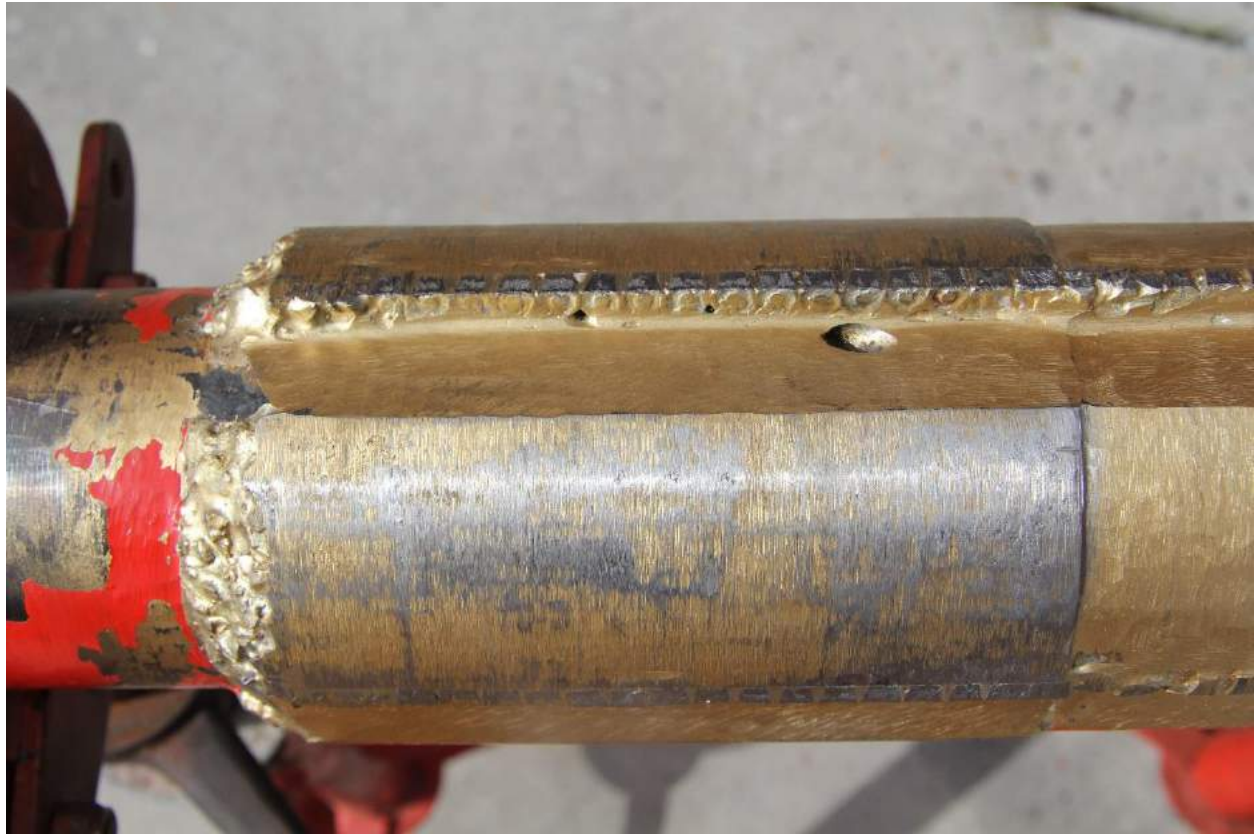
#5 – Mill still functional. Some damage primarily on the first cutter elements of each stage.

The Weatherford step mill demonstrated an acceptable overall performance and proved to be able to fulfill the scope of work. However it is sensitive to fluctuations in the WOM and caused several motor stalls that could significantly decrease motor lifetime in the HPHT environment of Ravn A-1.

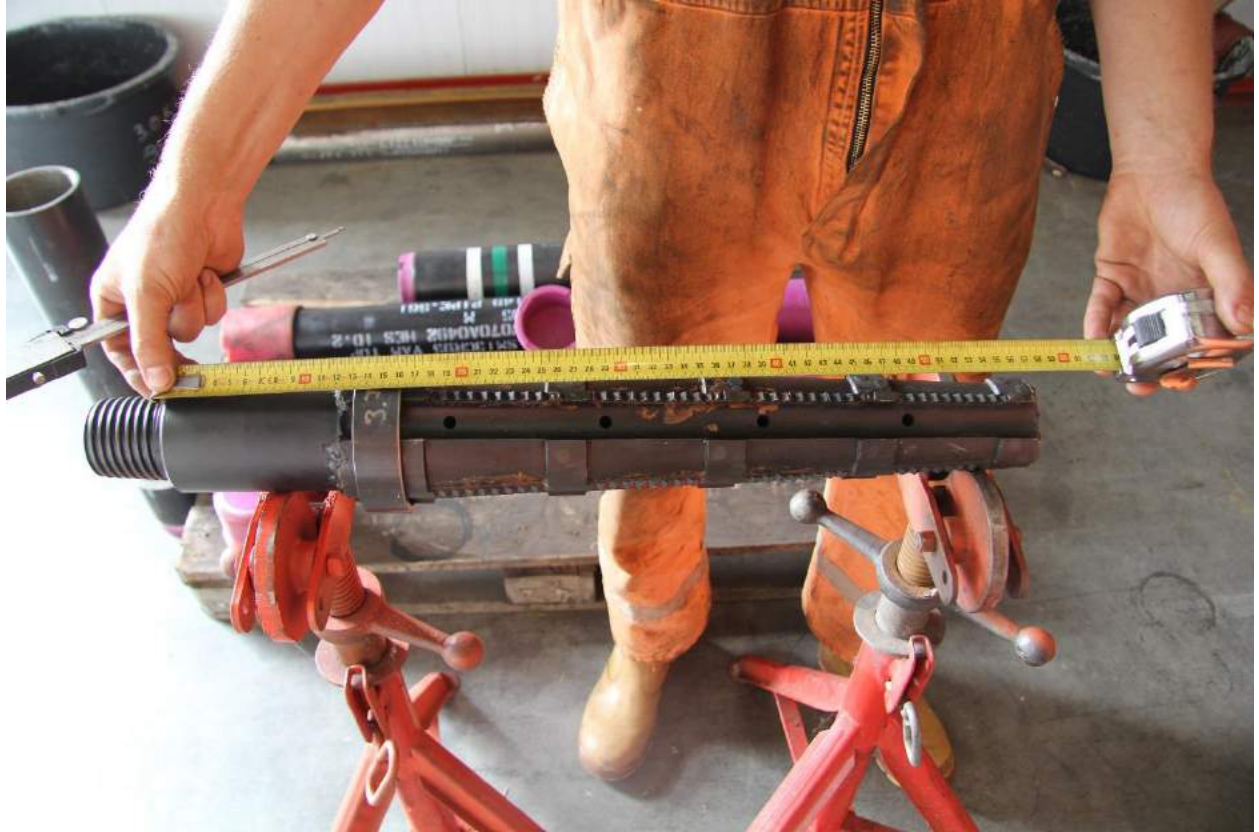
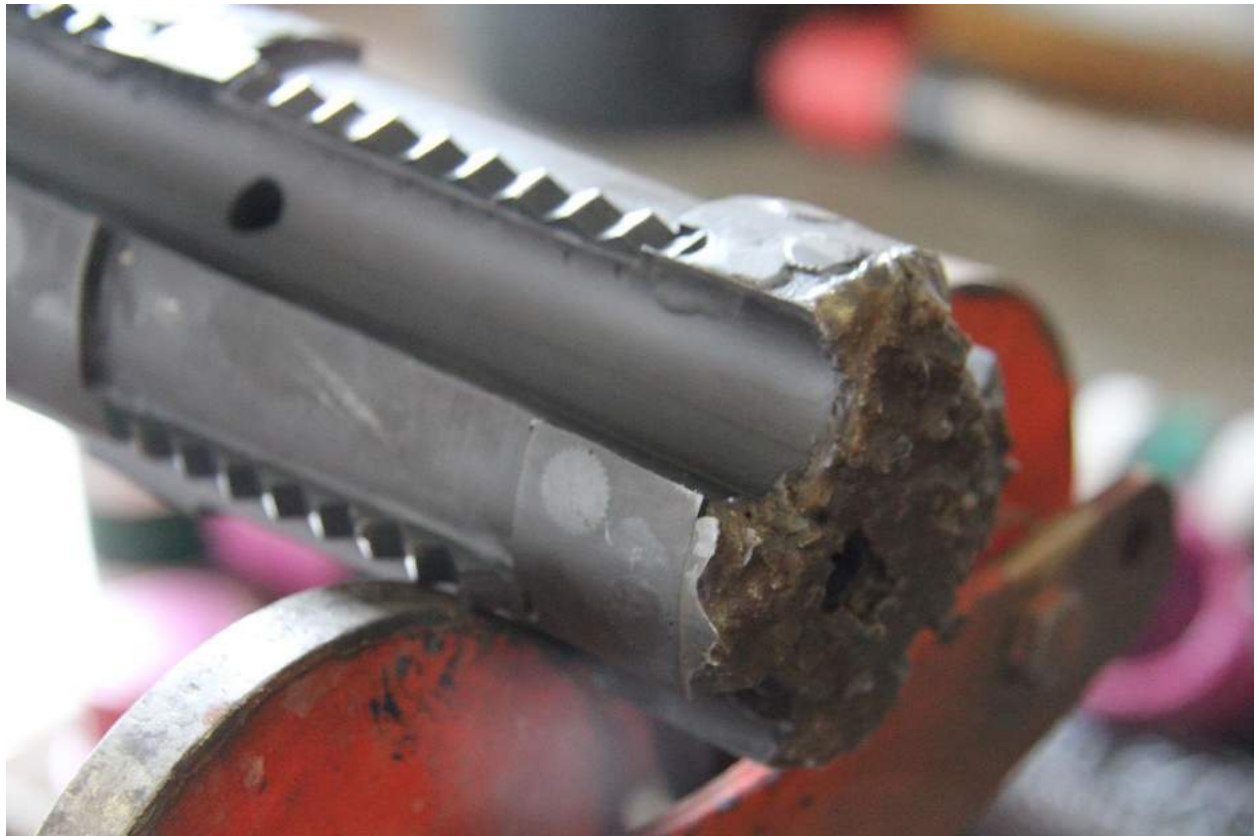
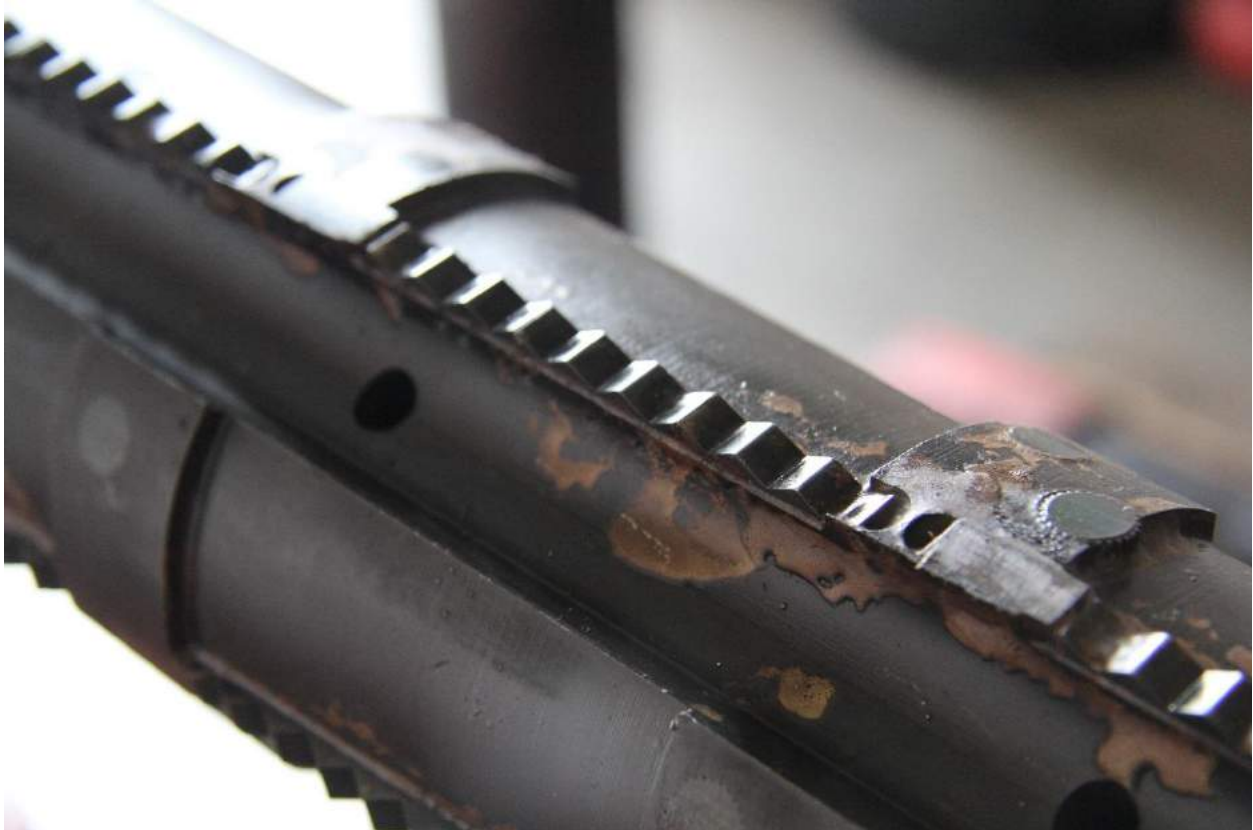
The ALS step mill is divided in four stages. Different to the Weatherford mill the stages are slightly tapered and not parallel. The stages are separated by guide rings with an OD of 2.7", 2.95", 3.2" and 3.45". Purpose of the guide rings is to support the mill to be in center when milling the ball seats. The mill is equipped with triangular shaped tungsten carbide cutter elements. It provides 16 circulation ports at the sides and 1 off centered circulation port at the nose. Circulation ports are larger than the ports of the Weatherford mill. It has backreaming features on the shoulder and tungsten carbide inserts on shoulder and guide rings for wear protection. On the first glance the mill appears more "aggressive" compared to the Weatherford mill.

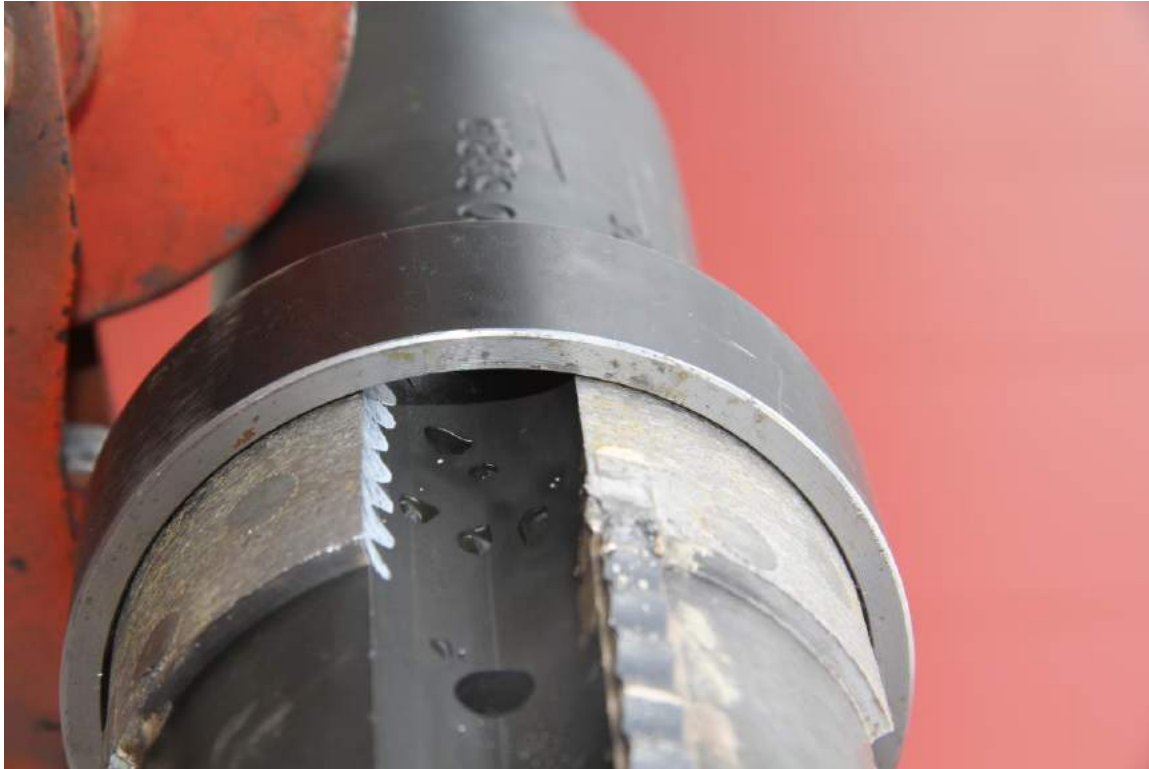
#1 – Drifted milled out ball seat with 3.7" – drift fits through ball seat sub.

#2 – Checked OD of the mill with 3.7" gauge ring – not undergauged in area with tungsten carbide buttons of the shoulder, slightly undergauged (3.69 – 3.695") in area with no tungsten carbide buttons on shoulder)

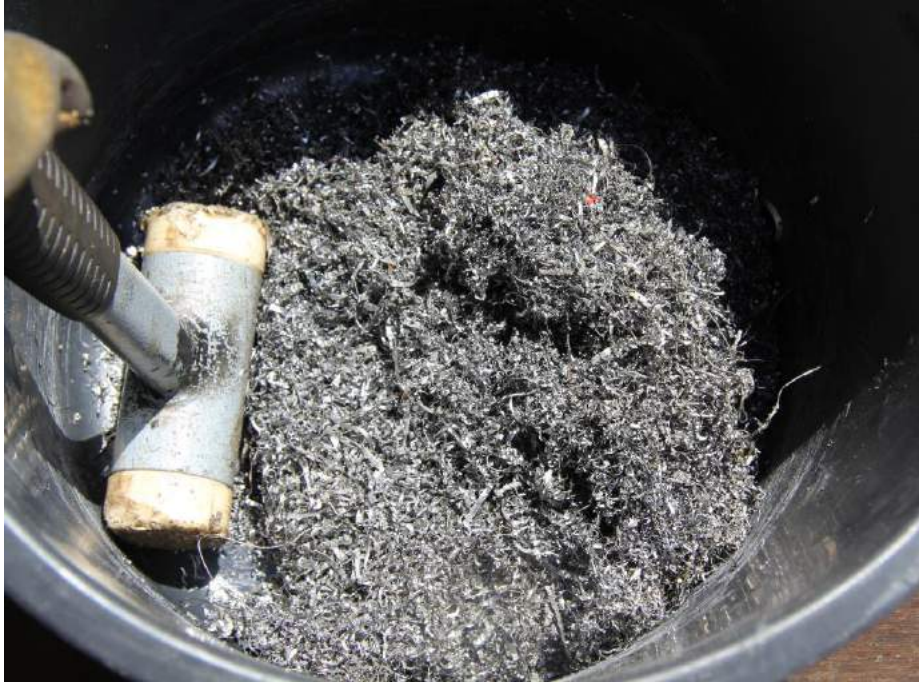
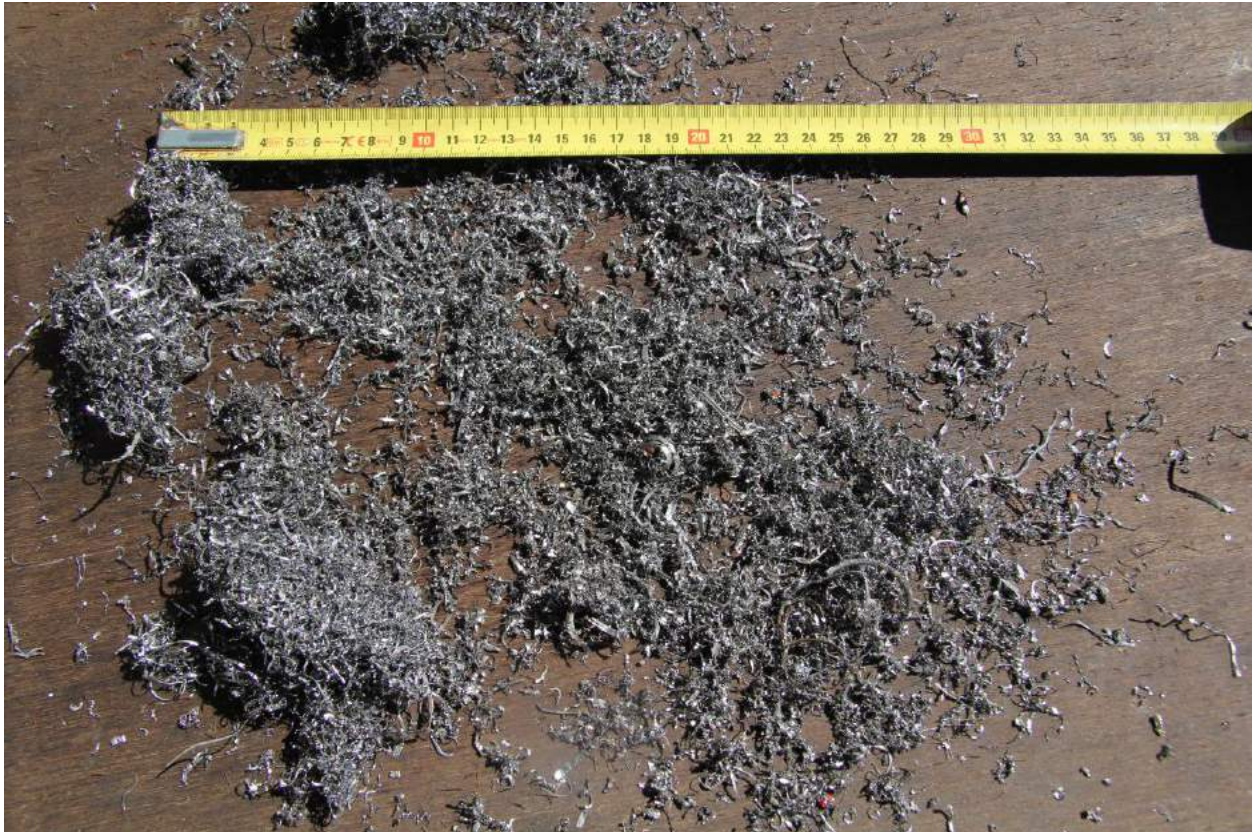
#3 – The ALS mill produced approx. three times more swarf compared to the ALS mill when milling ball seats of identical sizes. Looking at the size and shape distribution of the swarf, the swarf produced by the ALS mill is more homogeneous compared to swarf produced by the Weatherford mill. Suspect the Weatherford mill to produce more fines that bypassed the screens of the test bay.

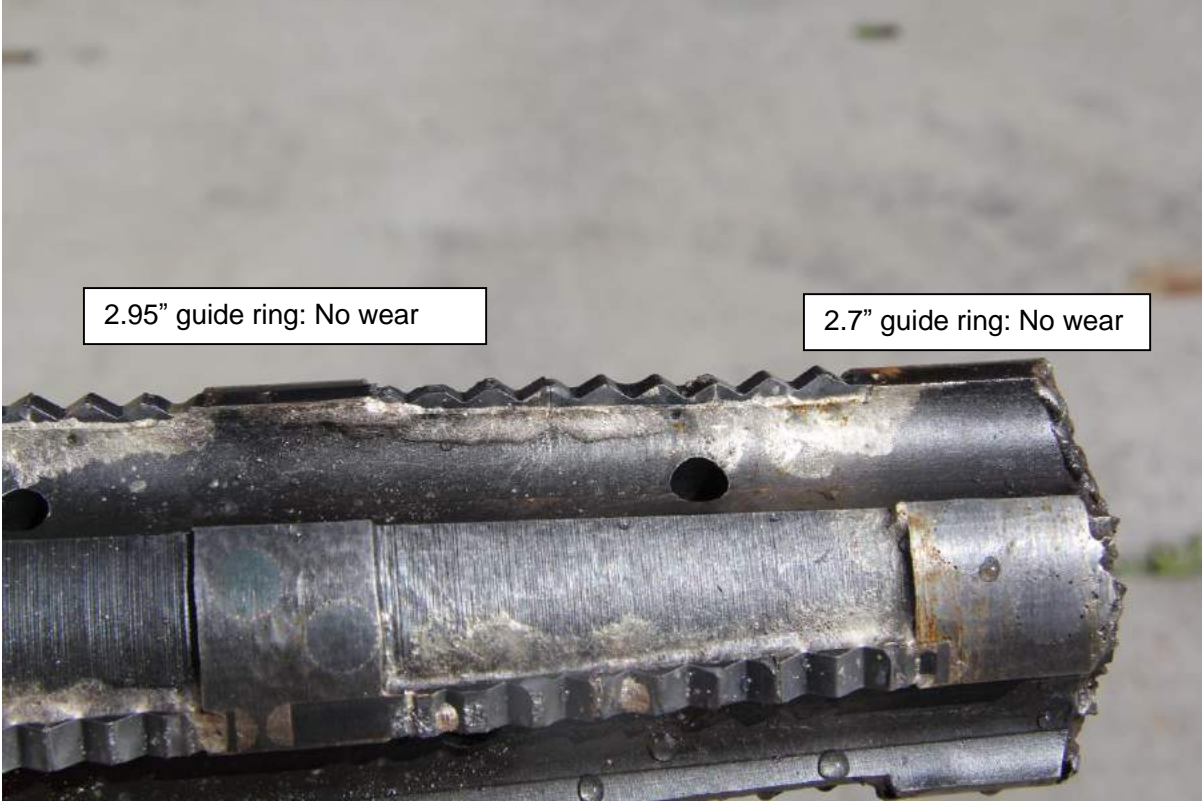
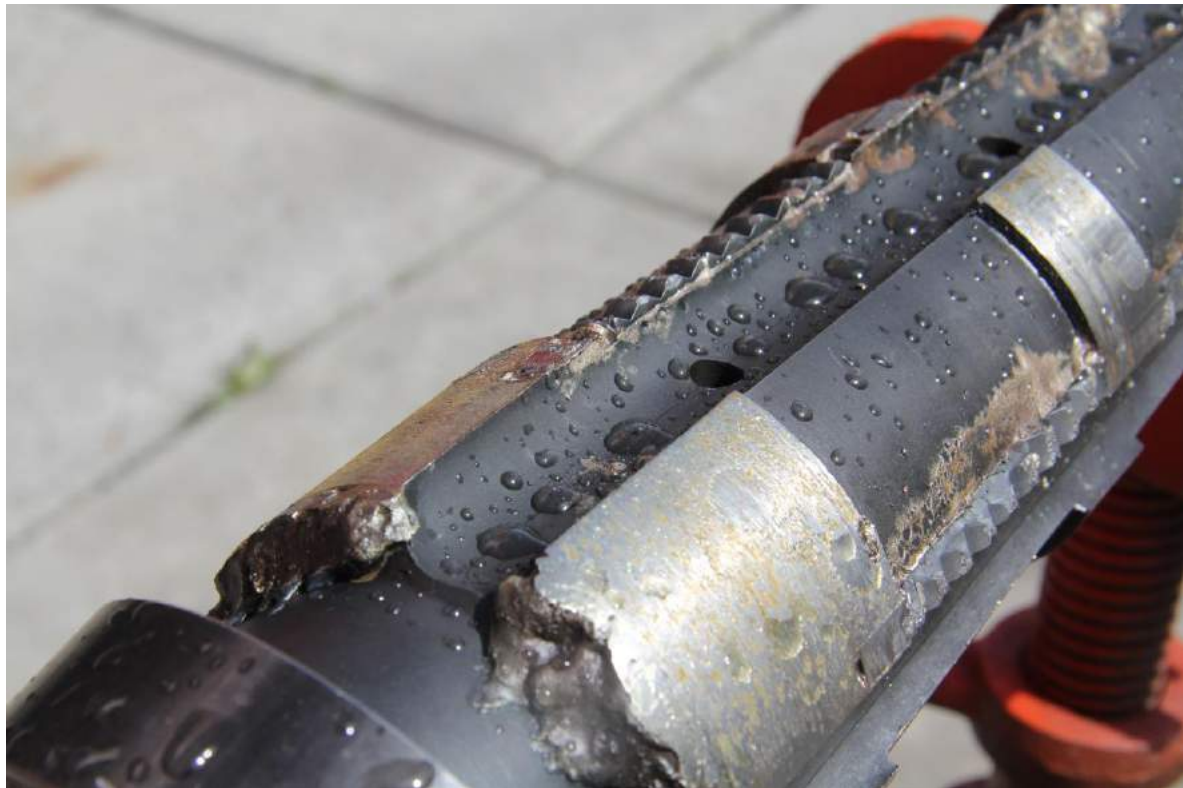
#5 – Mill still functional. Minor damage on the cutting structure. Wear on the 3.7” shoulder. Minor wear on the 3.4” guide ring. No wear on 2.95”, 3.2” and 2.7” guide ring.

Impressive performance of the ALS mill until the 3.7" shoulder reached the ball seat. 3.7" shoulder provides no active cutting action and needs modification. Plan ahead is to modify the mill with a half active cutting structure on the shoulder consisting of one row of tungsten carbide cutter elements. (similar to the Weatherford step mill - see pictures below). This modification should increase the performance of the mill in this area. If successful it is a clear favorite for the planned ball seat milling operations on Ravn A-1.
