Case History: Loose 718 Inconel Flapper

FREE/Oman ~ 718 Inconel flapper loose on top of L/ Nipple 3.437" No-Go.

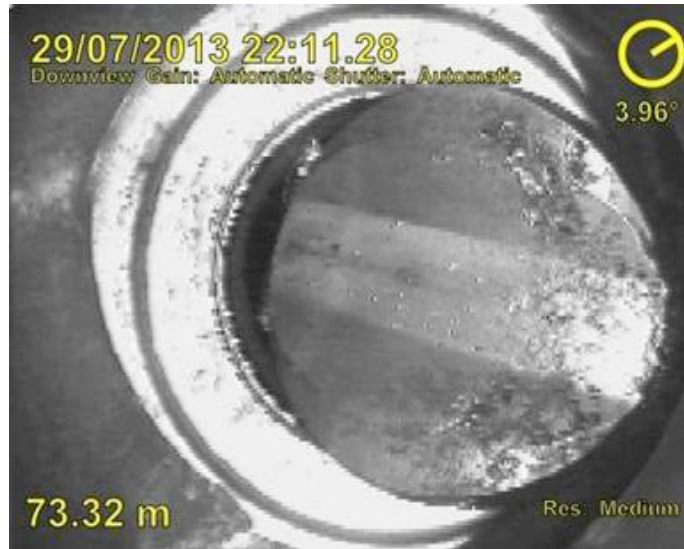
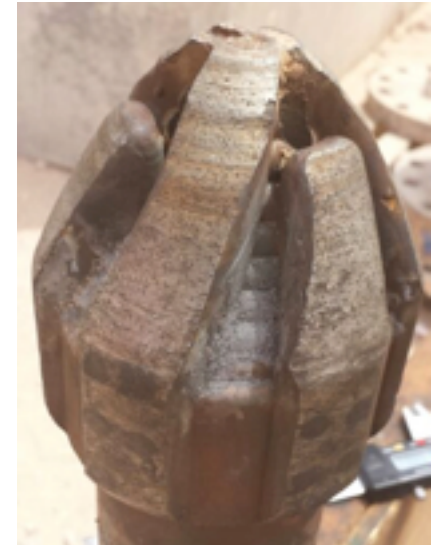
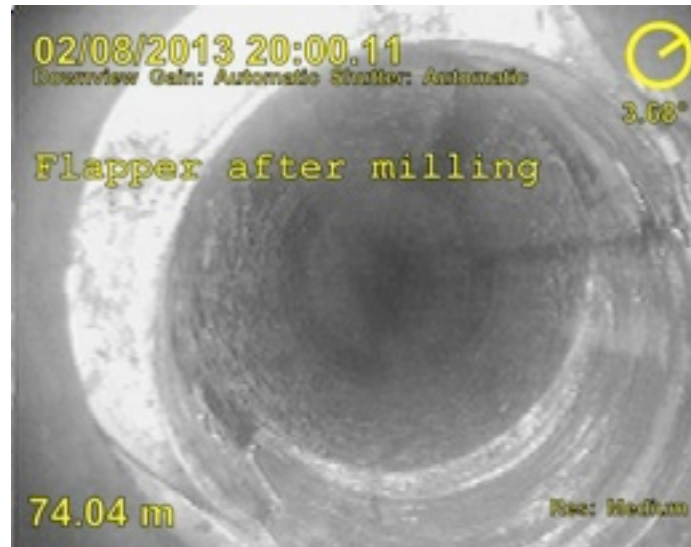
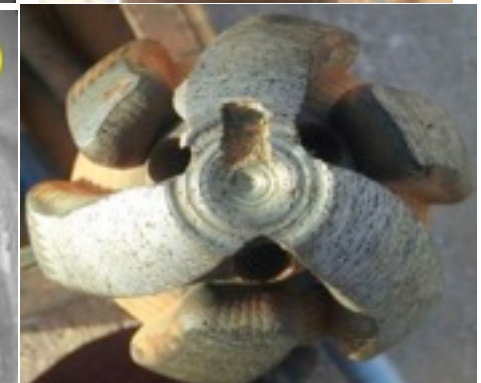
Estimate about 25% wear on diamond-impreg blades. No motor stalls and no cuttings.

Ran 3.500" MXT, Diamond-Impreg Mill and cut flapper and 0.4m of nipple in 6 hours.
