DME-P-305  
3.125" MZ-54

Short Bit & Tool Co.  
225 Gold St  
Garland, Texas 75042  
972-205-1011  
[shortbits@gmail.com](mailto:shortbits@gmail.com)

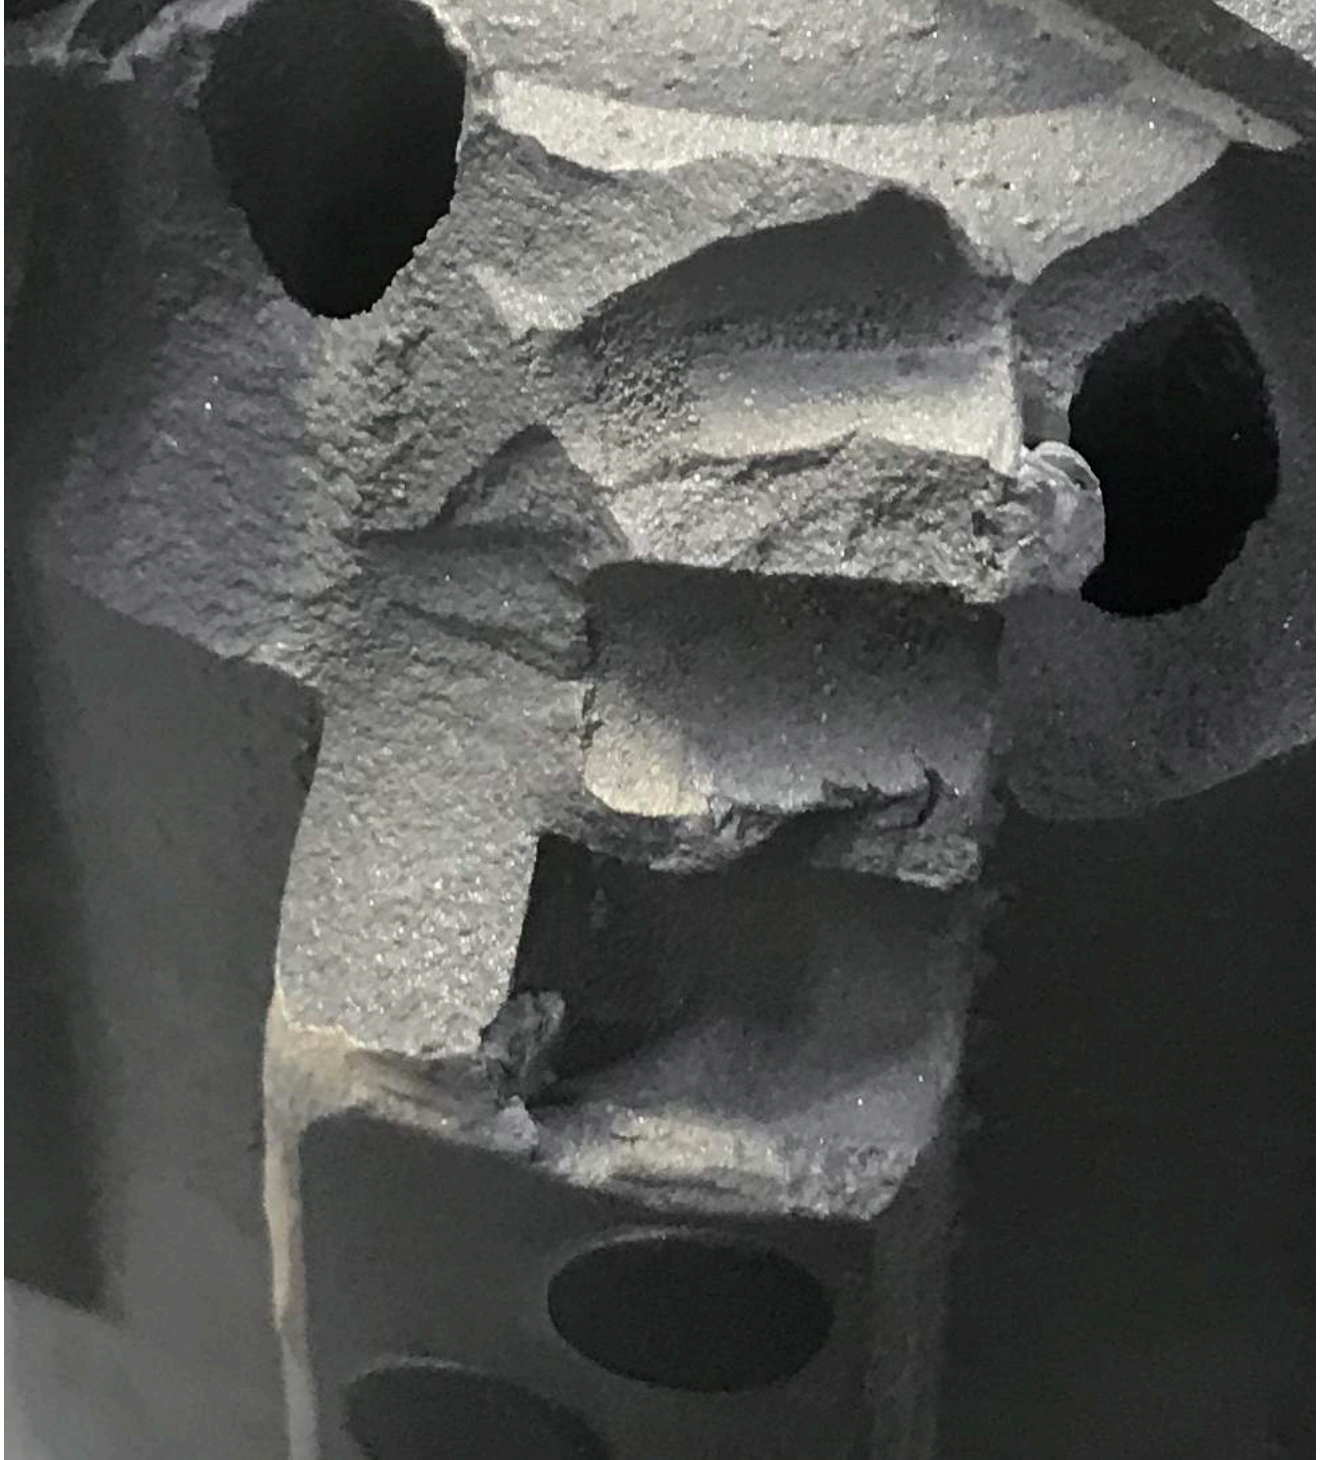
As shown in the above photo, the field pics we first saw looked like it could have been an incomplete braze, but upon closer examination we see that the braze was complete and it looks as though a very severe impact load was applied to the one side of the mill which broke a large section of matrix behind two blades.

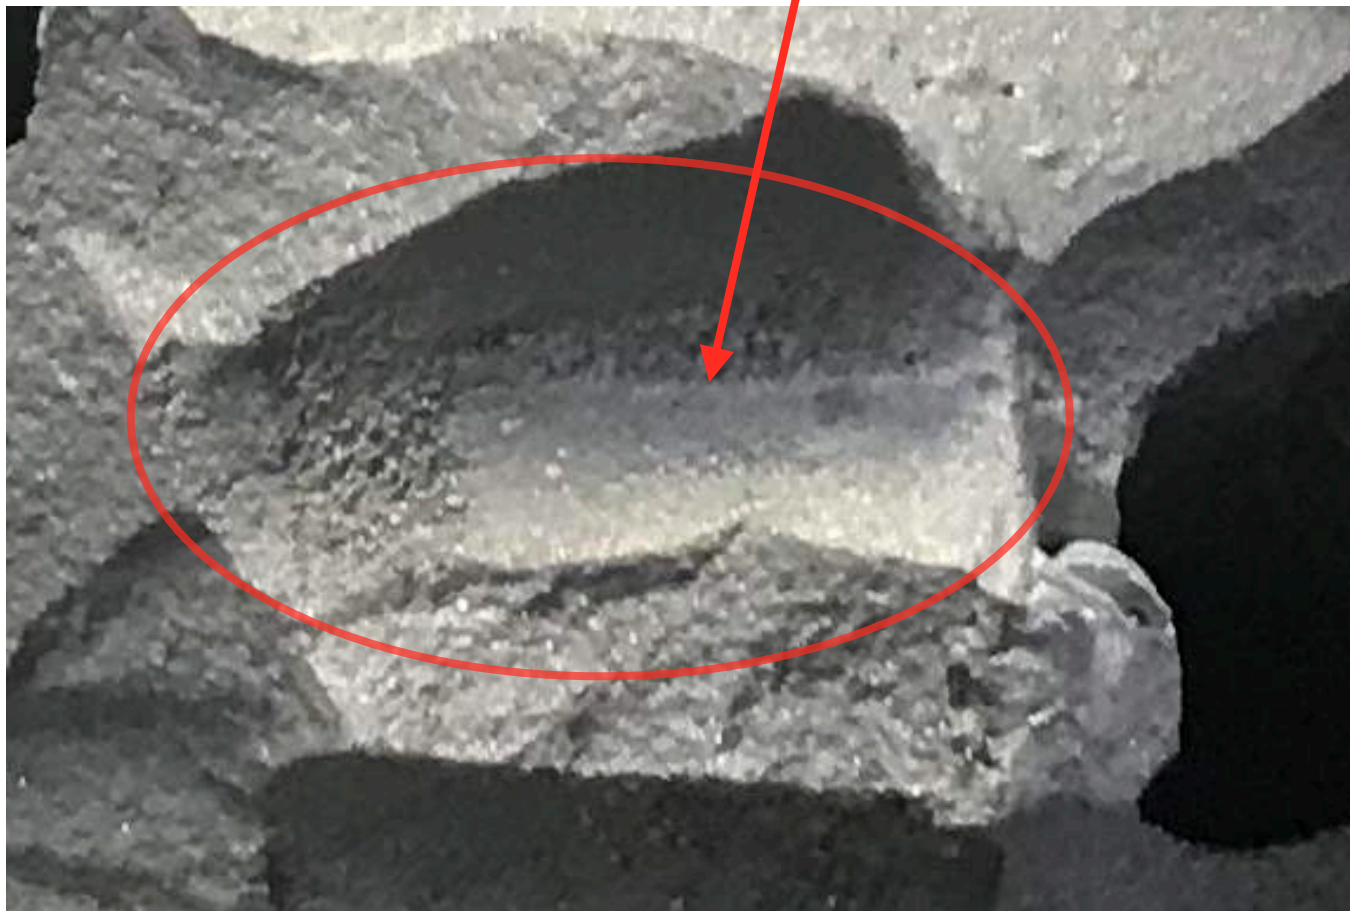
We know the braze was good because the braze being broken out of the pocket actually tore out part of the matrix.

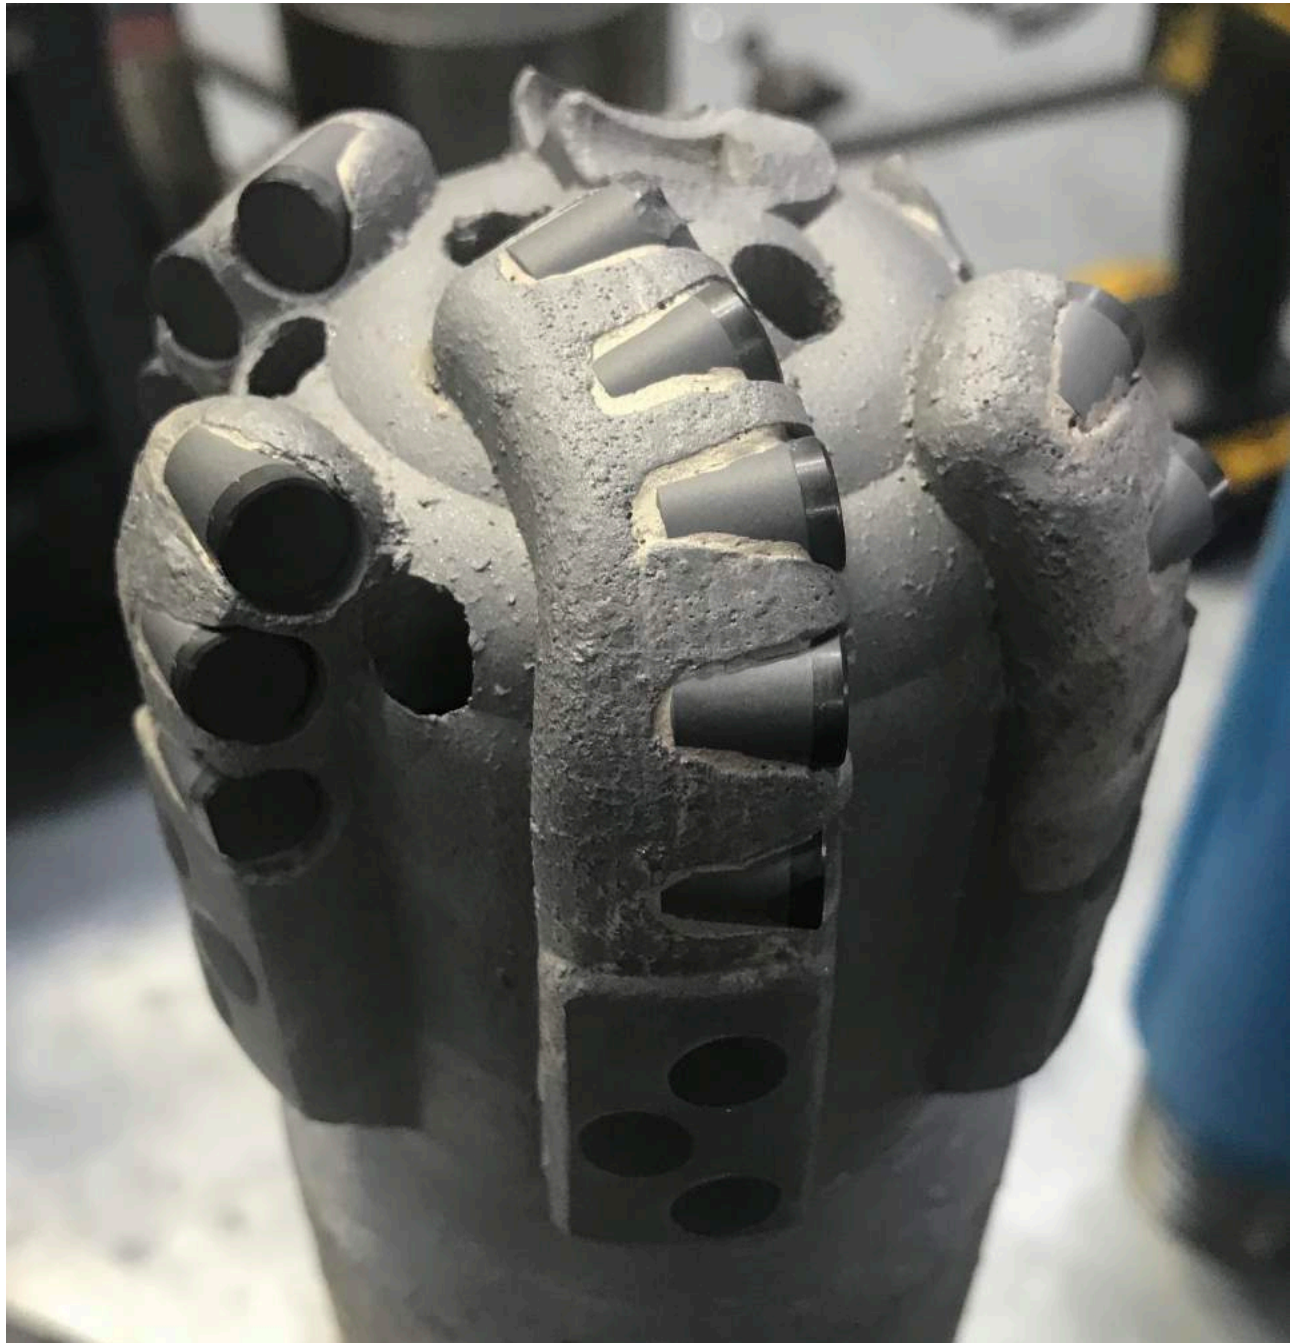
It is obvious the braze in the remainder of the mill is complete and solid.
