Case History

3.400" SBD-8 drilling SLB "Copper Head" Plugs Weatherford - Oman

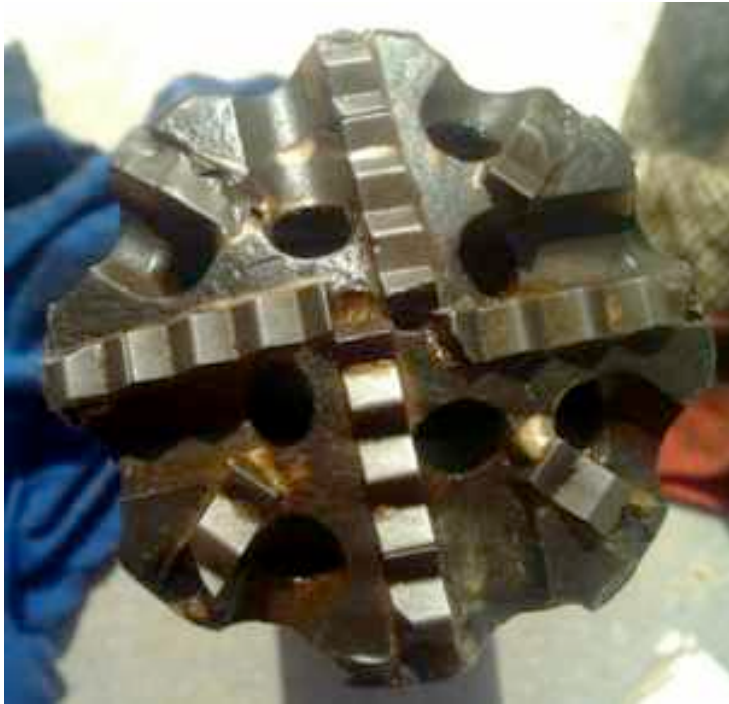
First Run used on motor/CT to drill **five SLB aluminum "copperhead" plugs** and "some other target" .
Mill had fractured inserts in outer 1/2".

Mill was refit

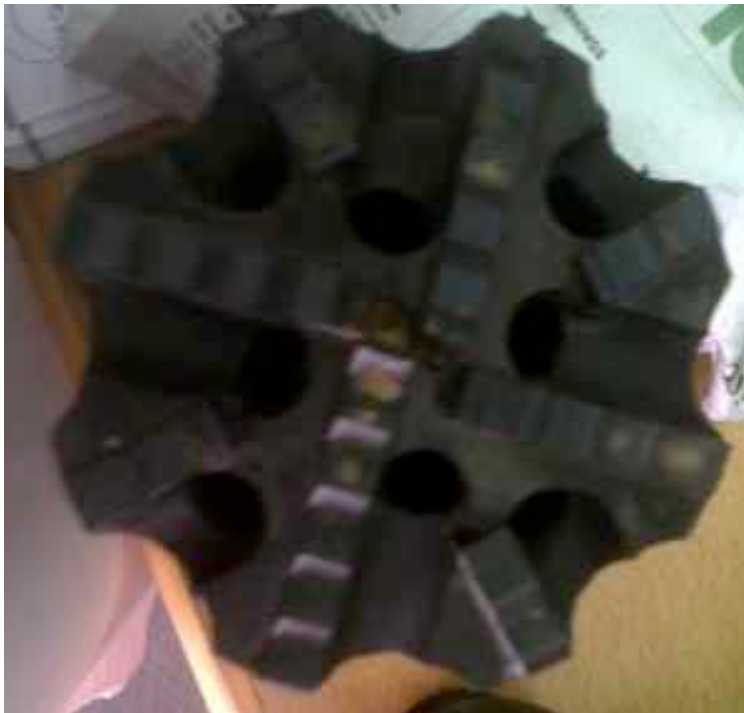
Second job mill was used to drill five aluminum copperhead plugs in 10 hours and is good for reruns.

The SDB mill ran with light WOB and almost no stalls.

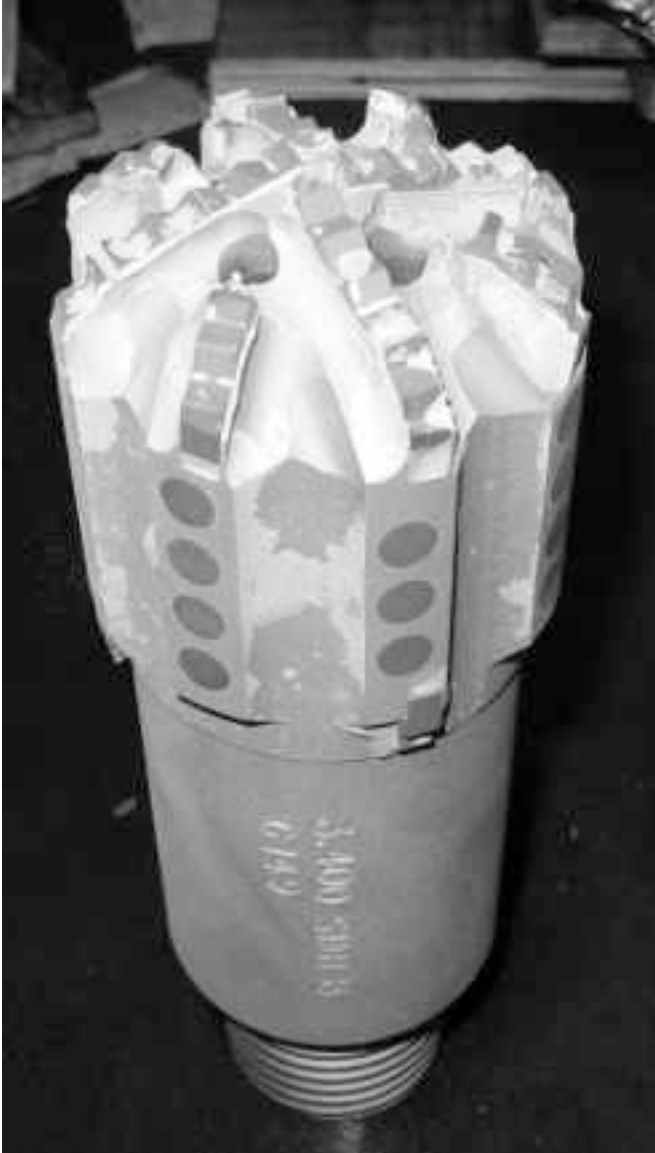
Third Run

SDB milled 11 copperhead plugs in one run at about 75 minutes per plug

No used photo, but the report was that it was good for rerun.
